MANUFACTURING RESEARCH INVESTIGATION
FINAL REPORT

NON-DESTRUCTIVE TESTING,
INSPECTION - PYROLYTIC GRAPHITE

MRI 228.05
12C SV60

6 June 1962

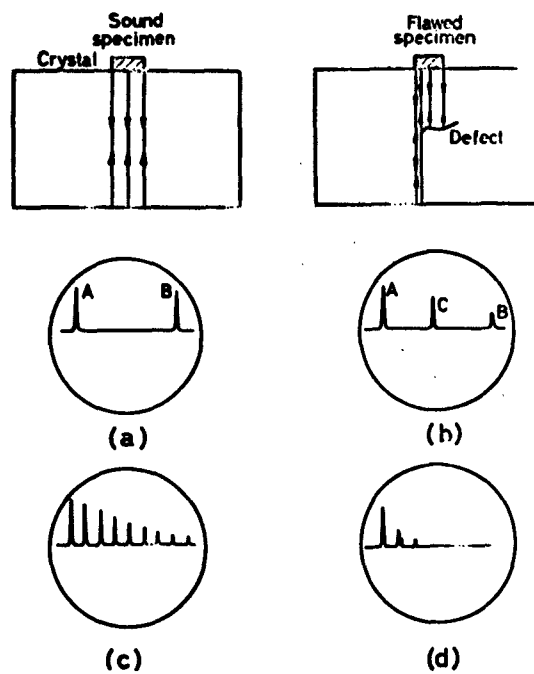
Figure 5

Typical indications of cathode ray oscilloscope
with pulse technique of ultrasonic testing.
     a. Sound specimen   b. Flawed specimen
     c. Sound specimen with low absorption coefficient
     d. Sound specimen with high absorption coefficient

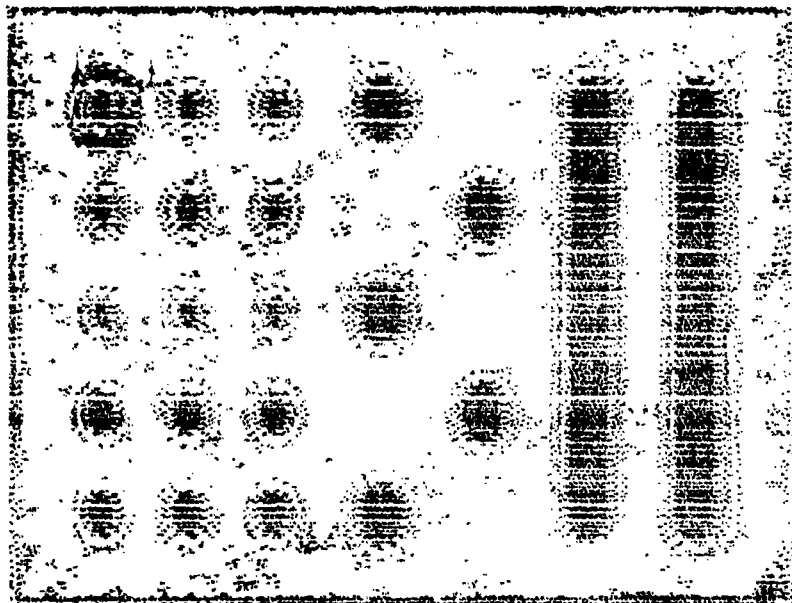
Figure 17

In Figure 17, a typical drill and ream operational specimen is shown.
The effect of this work is depicted by the ultrasonic trace (Figure
18). It is seen in this trace that some, though slight, delamina-
tions occur around the drilled and reamed areas.

MACHINING METHOD: DRILL, DRILL & REAM,

END MILL
FROM DEPOSITION SURFACE
NO SUPPORT

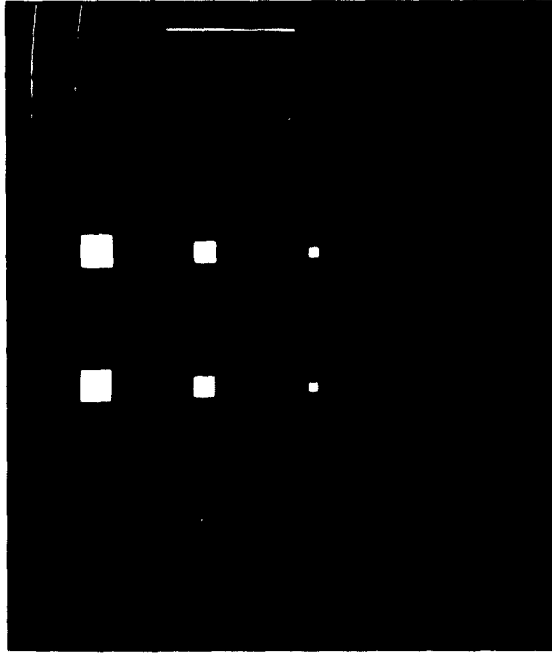
Figure 18

AFTER MACHINING
ULTRASONIC TRACES OF DRILL, REAMED

& MILLED SPECIMEN

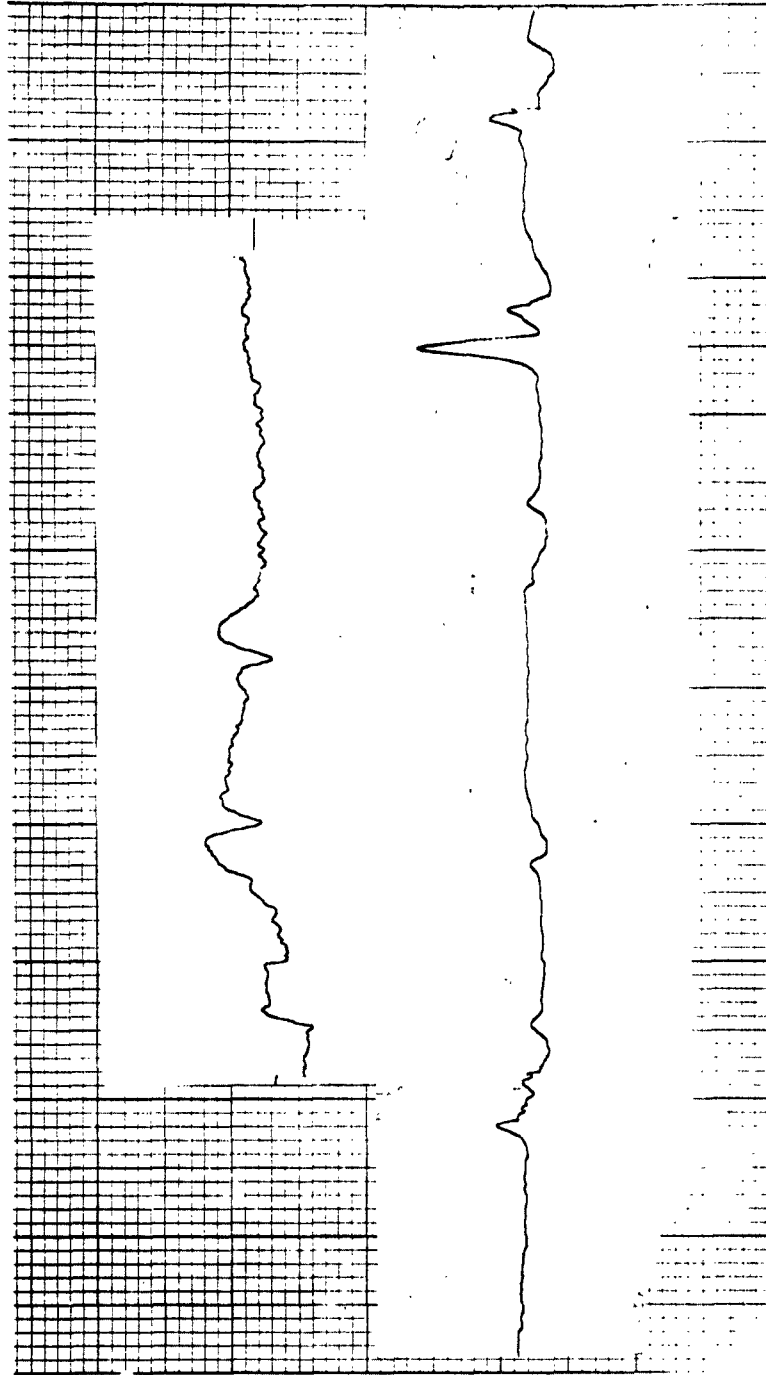
Figure 30

A typical thermal gradient trace, Figure 30, of a pyrolytic graphite specimen follows. The extreme dips or valleys illustrate imperfections and were correlated as such by both X-ray and ultrasonic test methods.

Thermal Gradient (Infra-red) Trace of Pyrolytic Graphite Samples
